Manhole Inspection Summary

Manhole # S150__027MH

Location Address: **410 BRUNSWICK ST**

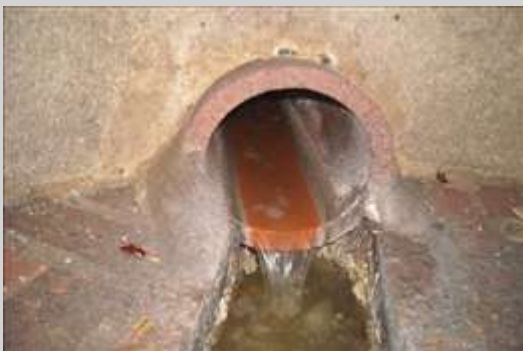
5 O'Clock Inflow

10 in. Circular Gravity Sewer
Pipe In @ 5 O'Clock

Pipe Height: **9.6** (in.) Rod and Bar (Angled)
Pipe Material: **Clay** ☐ Pipe Lined
Invert Depth: **11.97** (ft.) Flow Characteristics: **Slow**
Deposits: ☒ **None** ☐ Mud ☐ Sludge ☐ Debris ☐ Grease
Silt Depth: **0** (in.) Deposits Extent:
Infiltration: **None** Pipe Seal Cond: **Sound**
